# Manhole Inspection Summary

## Manhole # S11GG\_016MH

**Location** Address: **REAR OF 3116 BAKER ST** Cross Street: **ROSEDALE ST**

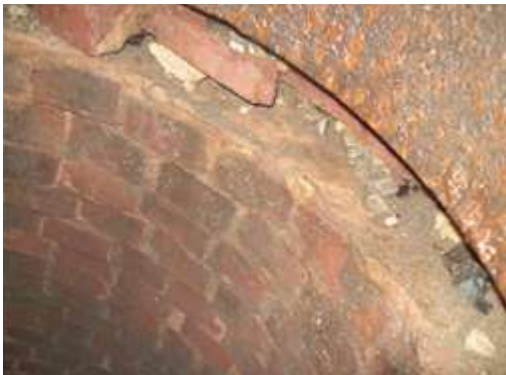
Defect 3

Condition: ☐ Sound ☒ **Cracked** ☐ Root Intrusion ☒ **Loose Brick** ☒ **Deteriorated**

deteriorated chimney

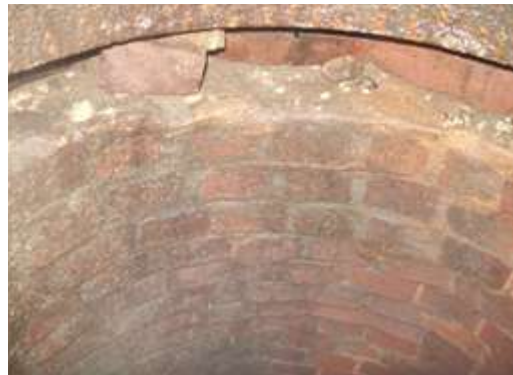
Defect 2

loose bricks

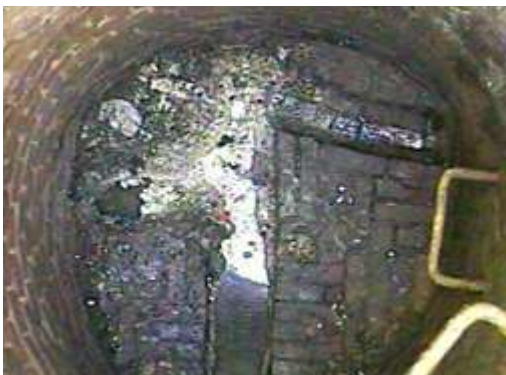
Defect 1

Comments **CHANNEL FULLY BLOCKED WITH EXCESSIVE AMOUNTS OF GREASE AND SLUDGE COVERING BENCH AND CHANNEL**

Condition: ☐ Sound ☐ Cracked ☐ Root Intrusion ☒ **Deteriorated** ☐ Leaks ☒ **Debris**

CHANNEL DEFFECTS

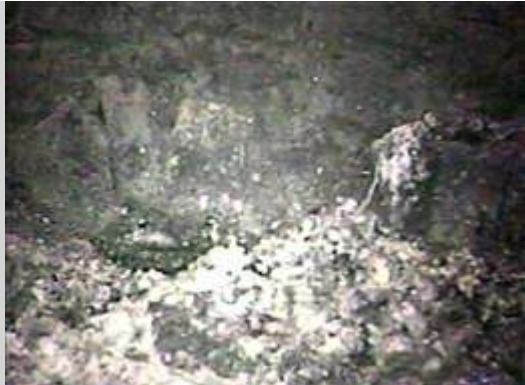
12 O'Clock Outflow

COMPLETELY CLOGGED - BARELY ABLE  
TO DISTINGUISH TOP SEAL OF PIPE

Deposits: ☐ None ☒ Mud ☒ ~~Gravy~~ ☒ Debris ☒ Grease

Silt Depth: **8** (in.) Deposits Extent: **Heavy**

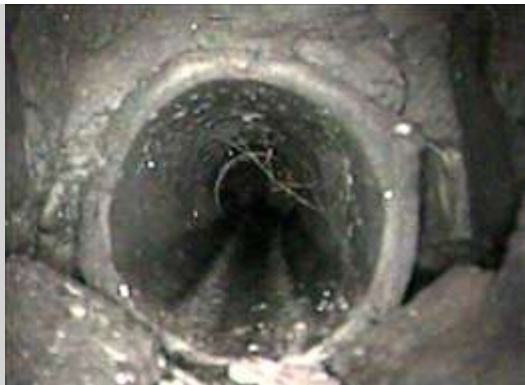
2 O'Clock Inflow

Infiltration: **None** Pipe Seal Cond: **Broken**

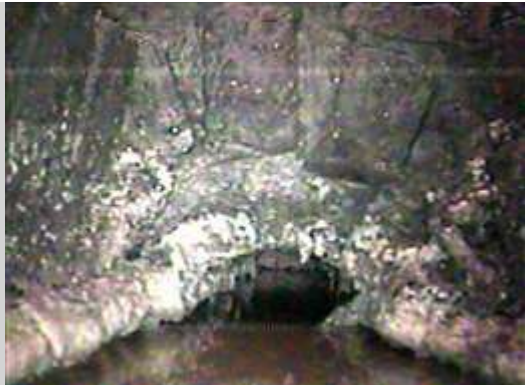
6 O'Clock Inflow

Deposits: ☐ None ☐ Mud ☒ Sludge ☐ Debris ☒ Grease

Silt Depth: **4** (in.) Deposits Extent: **Medium**
